A5120SI-CMW520-R1513P15 Release Notes

Comware software, Version 5.20, Release 1513P15

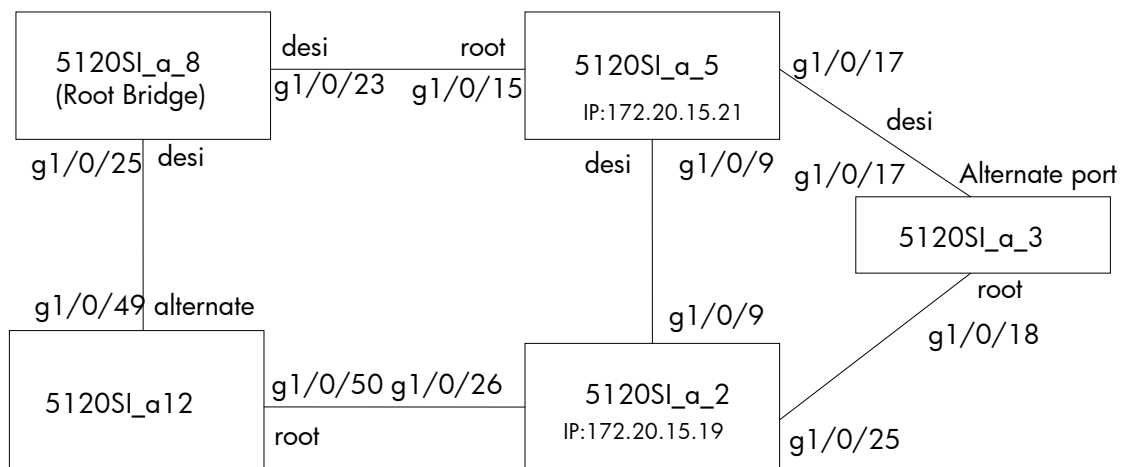
LSD45818

- Symptom: As shown below, if RSTP/MSTP is disabled and then enabled on 5120SI_a_2, the g1/0/25 and g1/0/26 ports of 5120SI_a_2 cannot quickly change to the forwarding state.
- Condition: When RSTP/MSTP is enabled and then disables RSTP/MSTP on a device that resides in a similar position with 5120SI_a_2.

- Workaround: Do not perform such operations.
