Hewlett Packard
Enterprise

HPE OneView 4.0 Release Notes for HPE Synergy

Part Number: P01319-001
Published: December 2017
Edition: 1

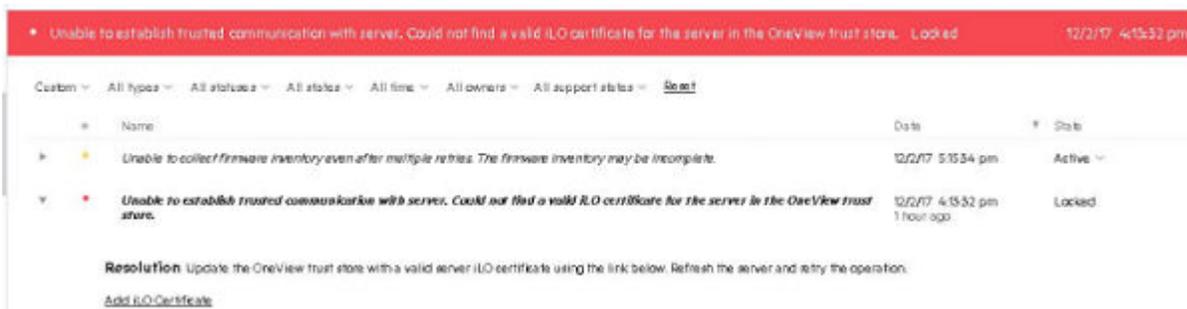
Communication with a managed device may fail despite the existence of the certificate in the trust store

Under very rare circumstances communication with a managed device may fail with an **unable to establish trusted communication** alert (shown below) despite the existence of the certificate in the trust store. The resolution to add the certificate will fail.

Suggested action

From the Settings > Security > Manage Certificate page:

- Delete the device certificate for which the communication failed
- Add the device certificate back with the same alias name
