ArubaOS 6.2.1.8

Release Notes

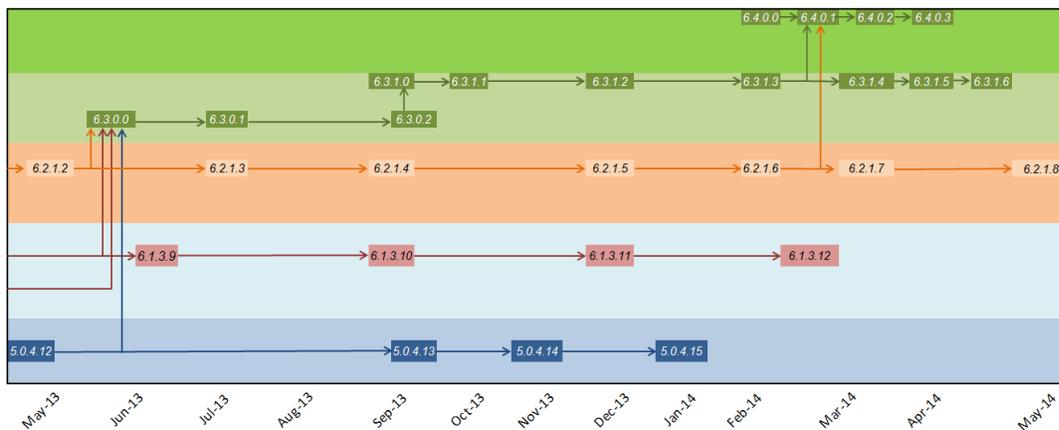
Figure 1 *ArubaOS Releases and Code Stream Integration*

The following illustration shows the patch and maintenance releases that are included in their entirety in ArubaOS 6.2.1.8.
