ArubaOS 7.2.2

Release Note

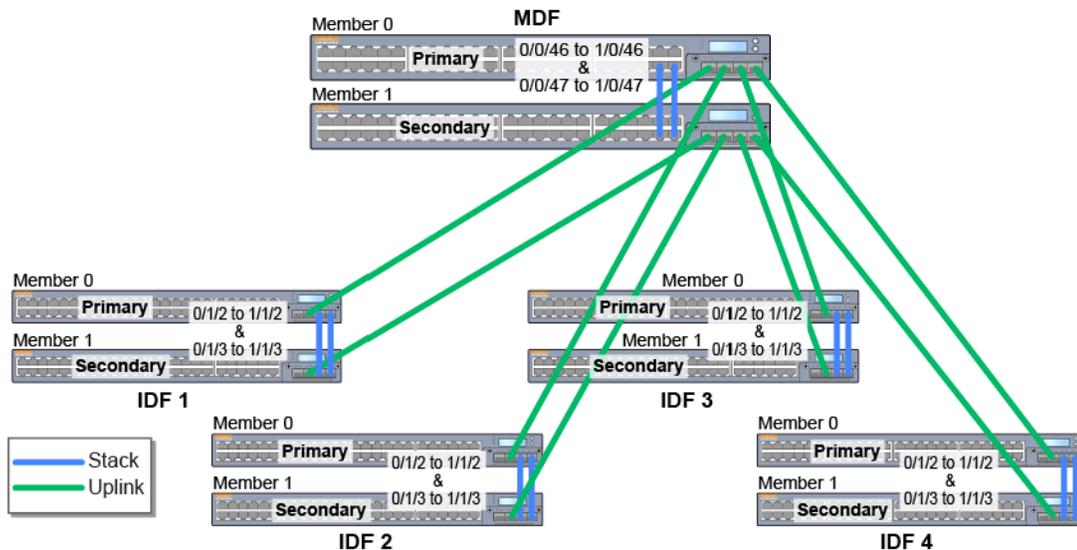
Figure 1 illustrates how to create an ArubaStack with 10/100/1000 base ports. This is useful when all the uplink ports are used for interconnecting with devices in the other locations.

Figure 1 ArubaStack with 10/100/1000 Base Ports

- Full redundancy is provided between every ArubaStack.
- Provides 1000BASE-T PoE on every ArubaStack.
- 1000Base-X (fiber) uplinks to MDF connect to the uplink ports.
- MDF stack is completed by 1000BASE-T base port links.
- x/0/x ports are stacked only with other x/0/x ports at MDF.

All the use cases are supported only with the exact interconnections as illustrated in the figures 1 to 4 provided in this document.

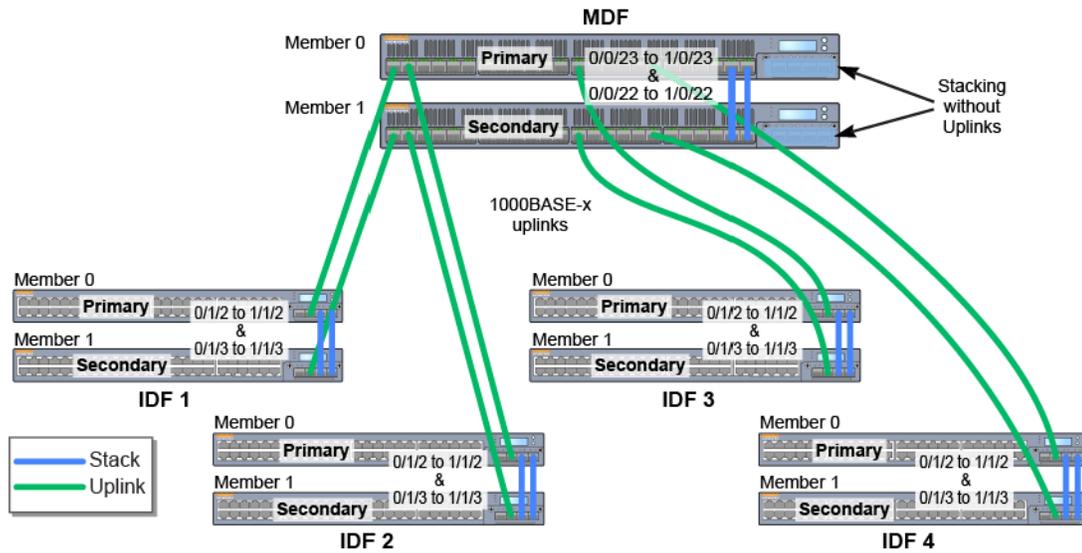
Figure 2 illustrates how to create an ArubaStack with S3500-24F base ports. This physical configuration is used to create a redundant S3500-24F aggregation layer without an uplink module.

Figure 2 ArubaStack with S3500-24F Base Ports

- Full redundancy is provided between every ArubaStack.
- No uplink module is required at MDF.
- 1000Base-X (fiber) uplinks to MDF connect to 1000Base-X base ports.
- MDF stack is completed by 1000BASE-X base port links.
- x/0/x ports are stacked only with other x/0/x ports at MDF.

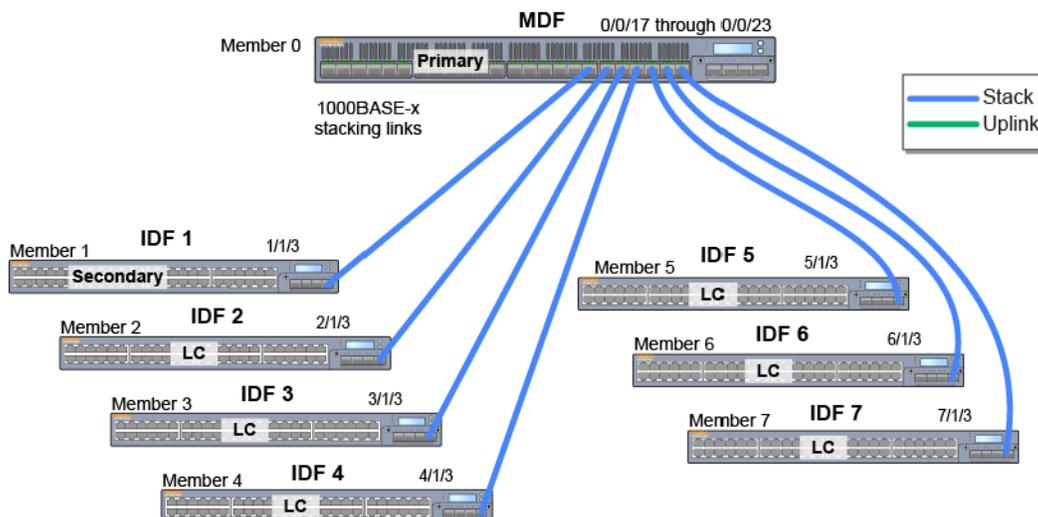
Figure 3 illustrates how to create an ArubaStack across multiple wiring closets. This is an alternative star topology used for multiple remote wiring closets instead of the traditional ring topology.

Figure 3 ArubaStack across Multiple Wiring Closets

- MDF and IDFs are integrated as one ArubaStack for simplified management.
- 1000Base-X Fiber extends ArubaStack to a longer distance.
- No uplink module is required at MDF.
- 1000Base-X (fiber) uplinks to MDF connect to 1000Base-X base ports.
- A maximum of 7 ArubaStack ports are allowed at MDF (S3500-24F shown).

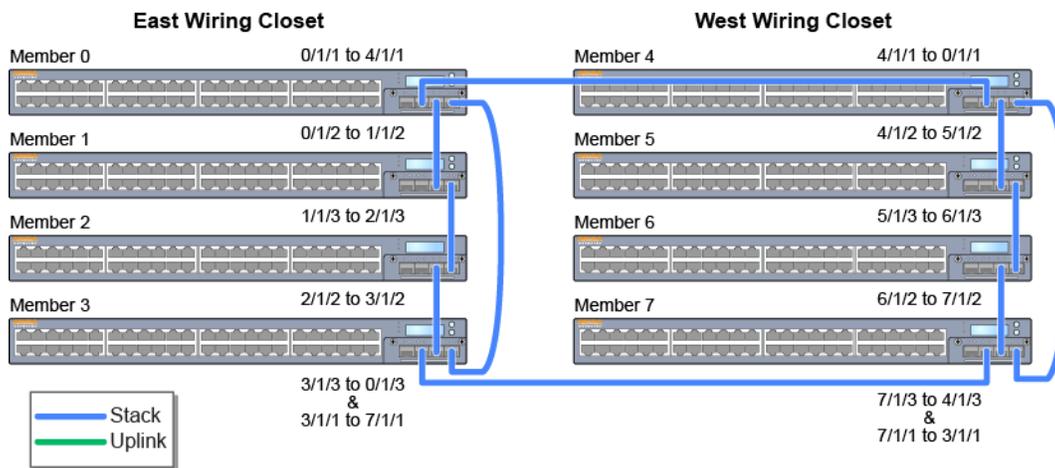
Figure 4 illustrates how to create an ArubaStack across two wiring closets with two layer redundancy.

Figure 4 ArubaStack across Two Wiring Closets with Two Layer Redundancy

- Primary member is in one closet and the secondary is in the other.
- DAC is provided between the members within the closet and 10GE is provided between the closets.
- Full redundancy is provided in each wiring closet
- Full redundancy is provided between closets
- Provides simplified management.
- Redundant uplink interfaces are available to core.
