Cisco Nexus 5000 Series and Cisco Nexus 2000 Series Release Notes, for Cisco NX-OS Release 5.0(2)N1(1) and NX-OS Release 5.0(2)N2(1)

Release: 5.0(2)N2(1) December 20, 2010
Part Number: OL-22747-02

This document describes the features, caveats, and limitations for Cisco Cisco Nexus 5000 Series switches and the Cisco Nexus 2000 Series Fabric Extenders. Use this document in combination with documents listed in the “[Related Documentation](#)” section on page 44.

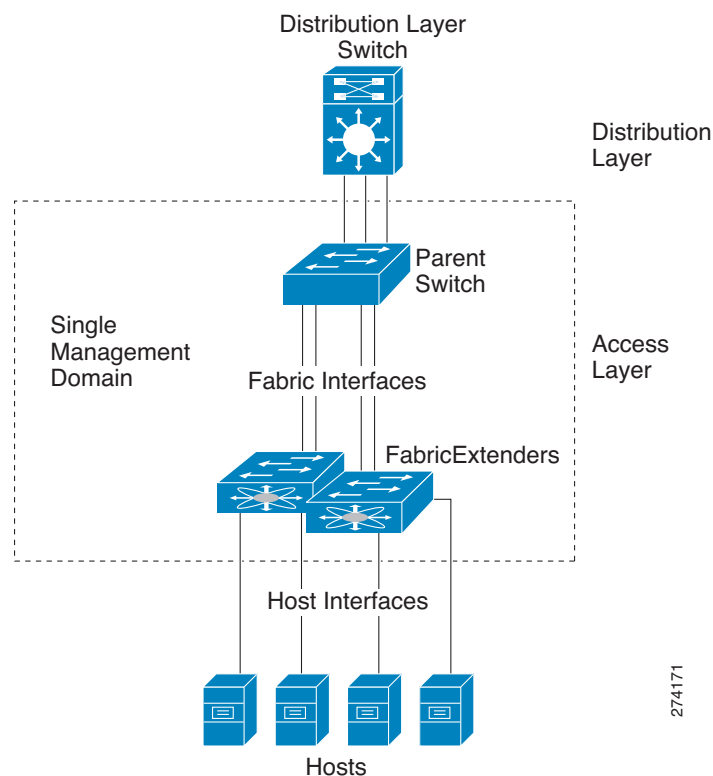
Figure 1 *Single Management Domain*

The Fabric Extender integrates with its parent switch, allowing zero-touch provisioning as well as automatic configuration. This integration allows large numbers of servers and hosts to be supported using the same feature set as the parent Cisco Nexus 5000 Series switch, including security and quality of service (QoS) configuration parameters, with a single point of management as shown in [Figure 1](#). Spanning Tree Protocol (STP) is not required between the Fabric Extender and its parent switch, because the Fabric Extender and its parent switch allow you to enable a large multi-path, loop-free, active-active topology.
