Hewlett Packard
Enterprise

FibrChanl-03 (fcoc) Fibre Channel Mass Storage Driver for HP-UX 11i v3 Release Notes

Version Number B.11.31.1705

Part Number: 814123-004
Published: June 2017
Edition: 3.0

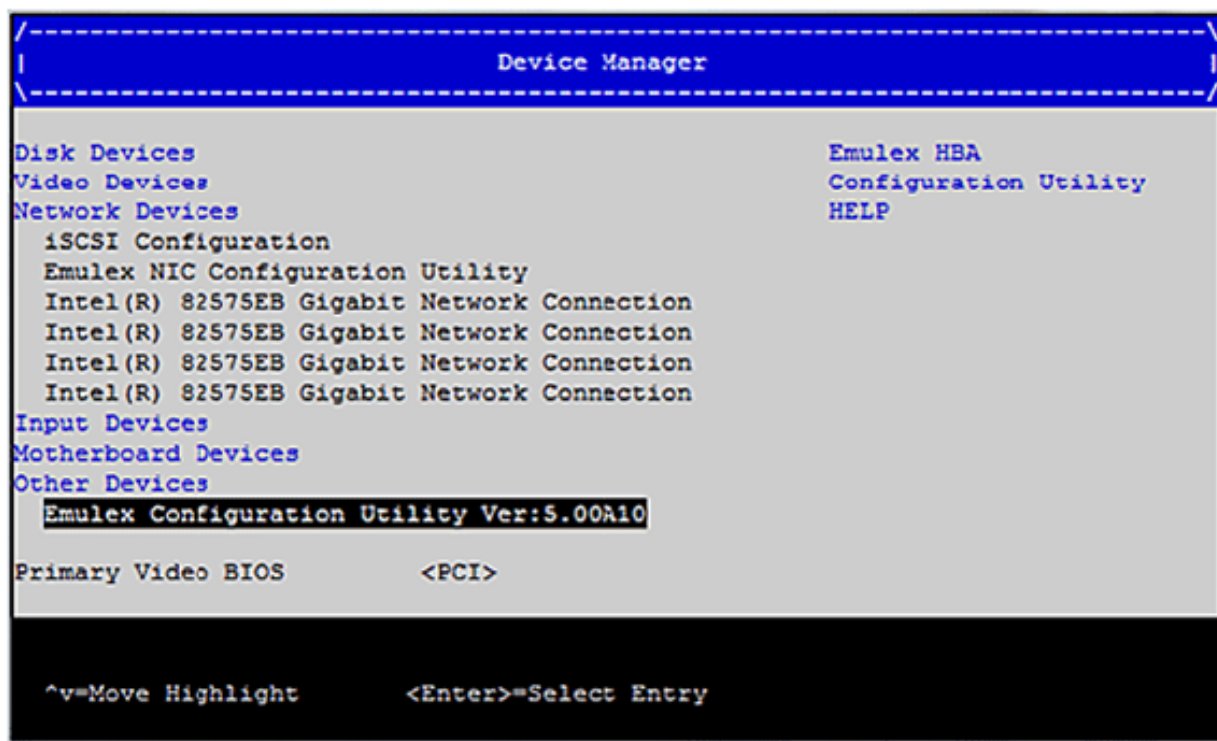
1. Launch the Device Manager. A front page is displayed.

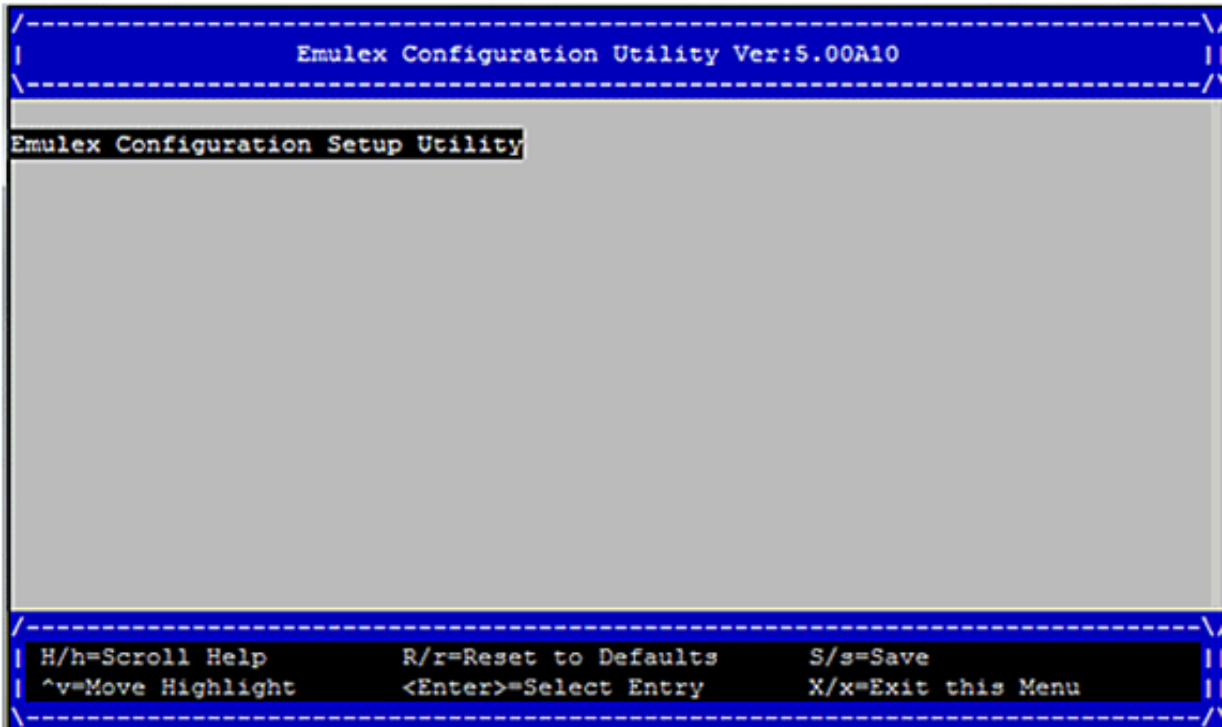
Emulex Configuration Setup Utility Screen

2. Select **Emulex Configuration Utility Ver:X.XXXXXX** and press **Enter**.
3. When the **Emulex Configuration Utility** screen is displayed with **Emulex Configuration Setup Utility** selected, press **Enter**.

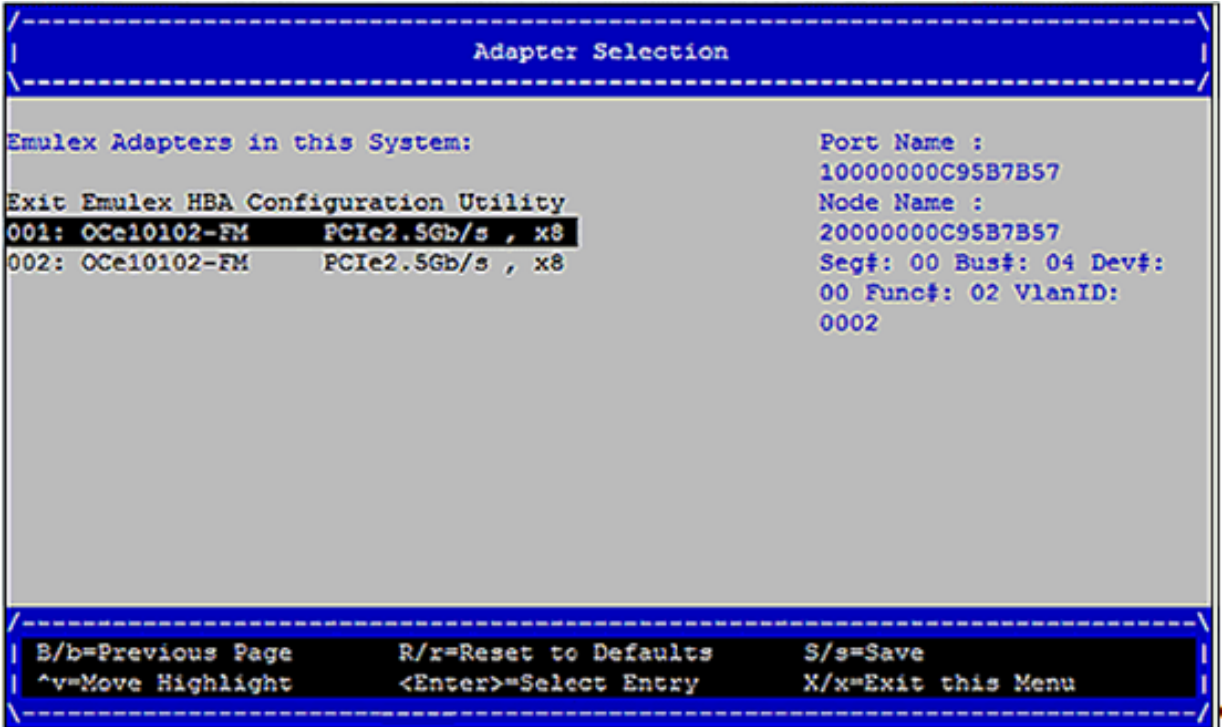
Adapter Selection Screen

4. A list of all the adapters in the system is displayed. Your list may vary depending on the installed adapters. Locate the adapter you want to configure. Use the up/down arrows on your keyboard to select it, and press **Enter**.
