HP 5900_5920-CMW710-R2209

Release Notes

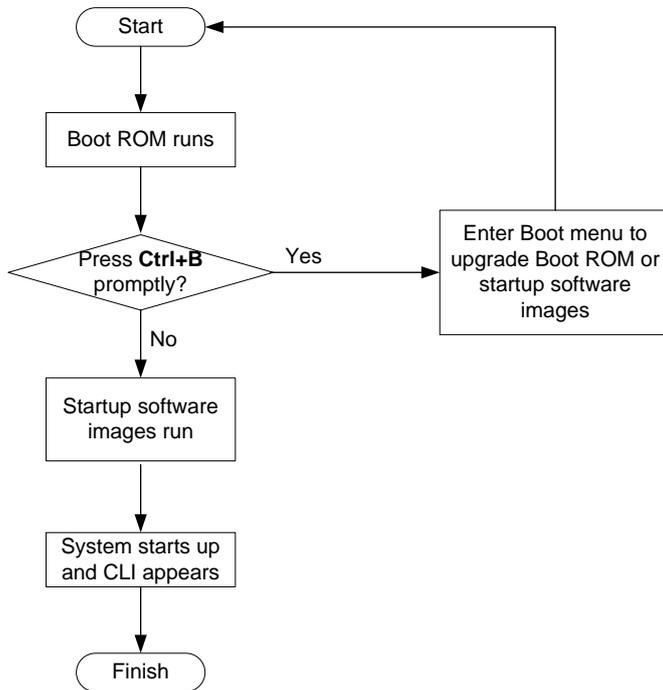
Upon power-on, the Boot ROM image runs to initialize hardware and then the software images run to start up the entire system, as shown in [Figure 1](#) .

Figure 1 System startup process

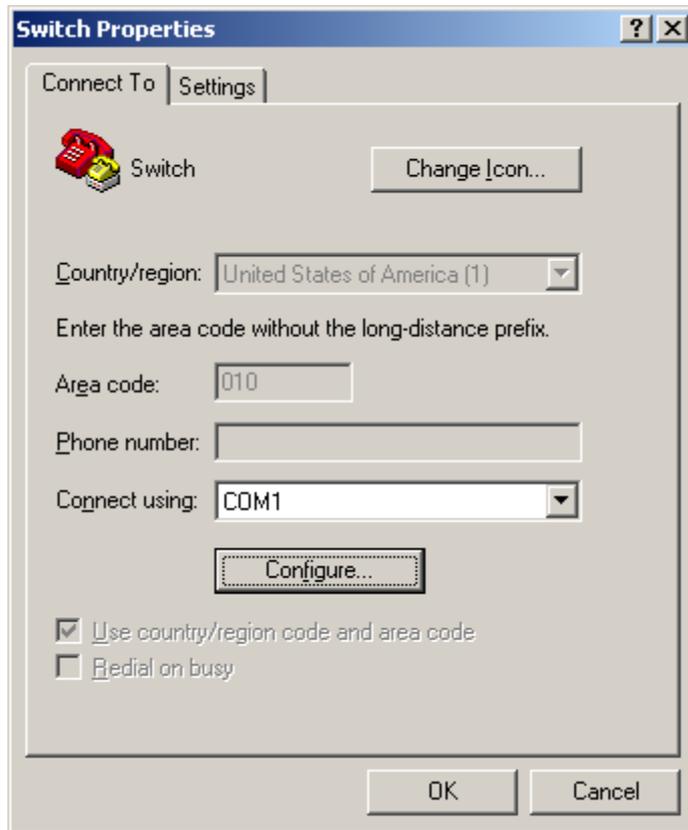
6. Select **File > Properties**, and in the **Properties** dialog box, click **Configure**.

Figure 3 Properties dialog box

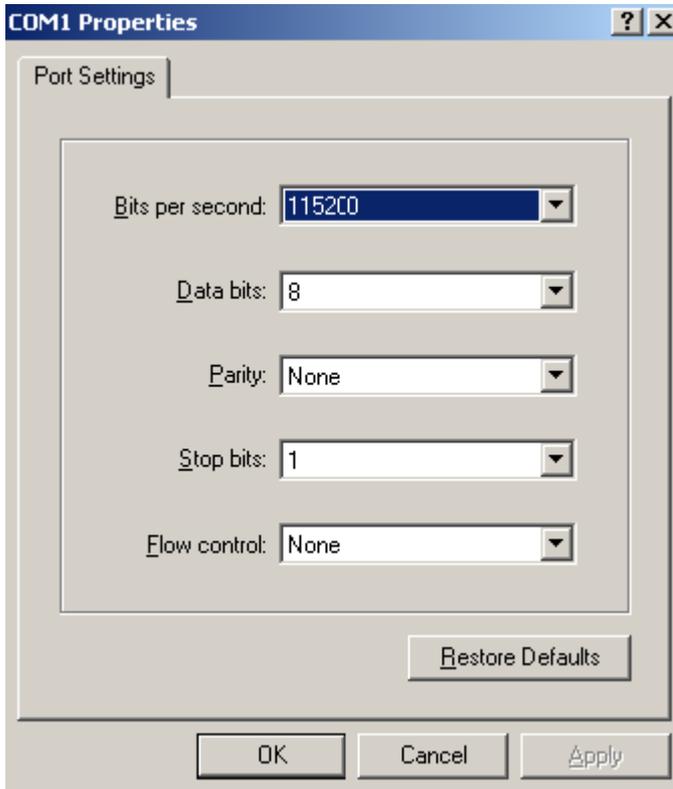
7. Select **115200** from the **Bits per second** list and click **OK**.

Figure 4 Modifying the baud rate

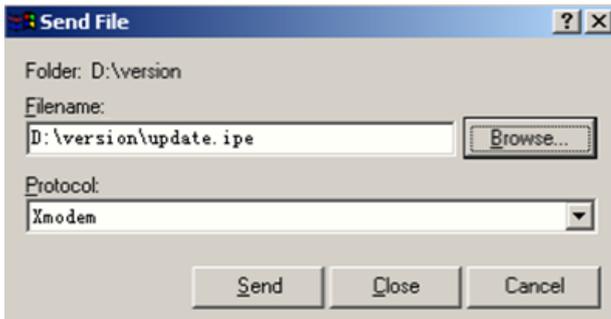
12. In the dialog box that appears, click **Browse** to select the source file, and select **Xmodem** from the **Protocol** list.

Figure 7 File transmission dialog box

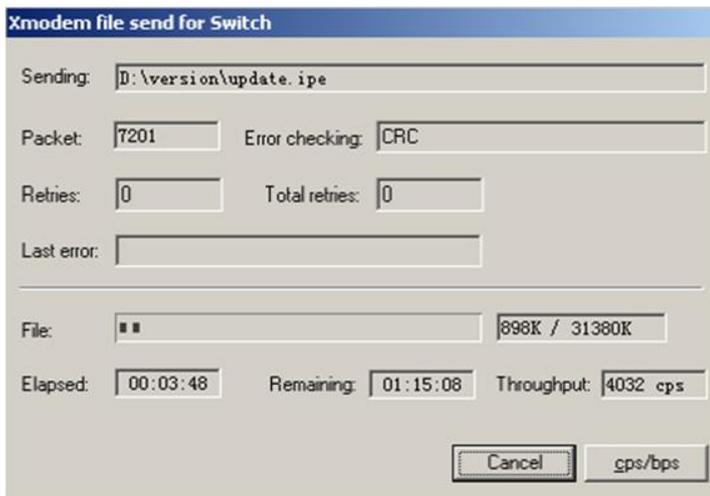
13. Click **Send**. The following dialog box appears:

Figure 8 File transfer progress

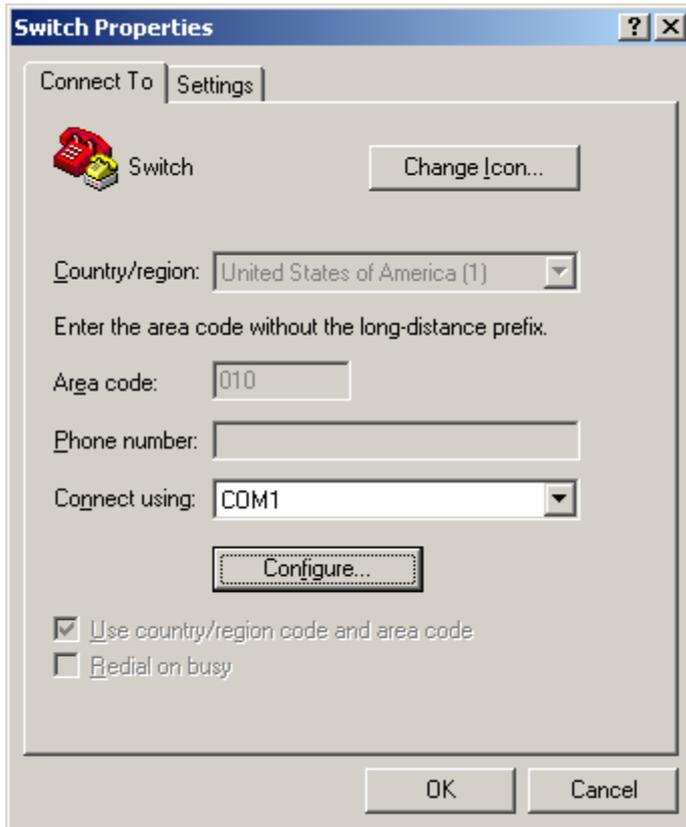
7. Select **File > Properties**, and in the **Properties** dialog box, click **Configure**.

Figure 10 Properties dialog box

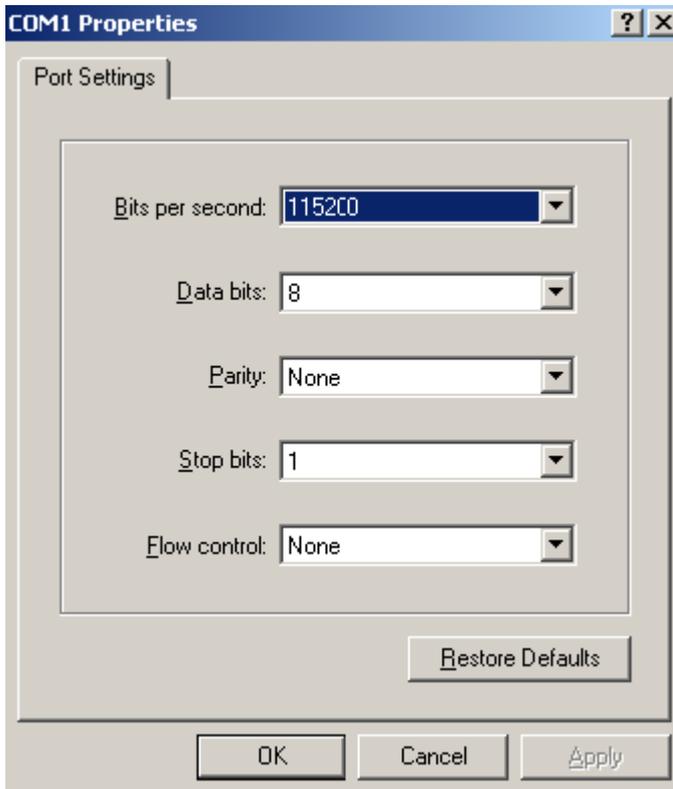
8. Select **115200** from the **Bits per second** list and click **OK**.

Figure 11 Modifying the baud rate

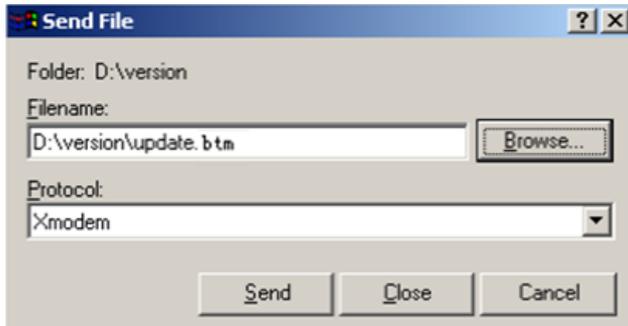
- In the dialog box that appears, click **Browse** to select the source file, and select **Xmodem** from the **Protocol** list.

Figure 14 File transmission dialog box

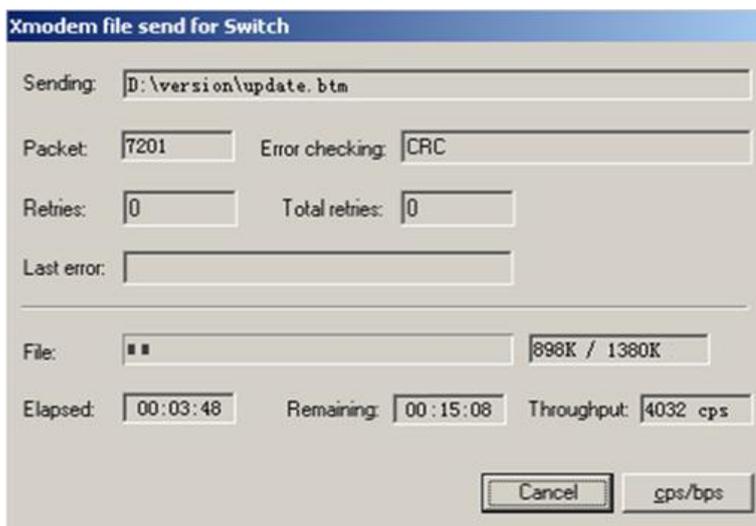
- Click **Send**. The following dialog box appears:

Figure 15 File transfer progress
