Release Notes:

Version E.09.02 Software

for the HP ProCurve Series 5300XL Switches

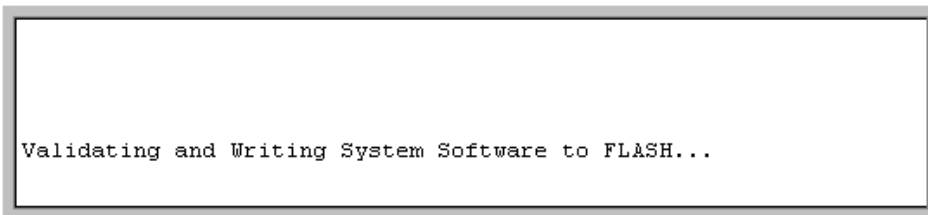
2. When the switch finishes downloading the software file from the server, it displays this progress message:

Figure 1. Message Indicating the Switch Is Writing the Downloaded Software to Flash Memory
