Release Notes:

Version K.14.32 Software

for the HP ProCurve Series 3500yl, 6200yl, 5400zl and 8212zl Switches

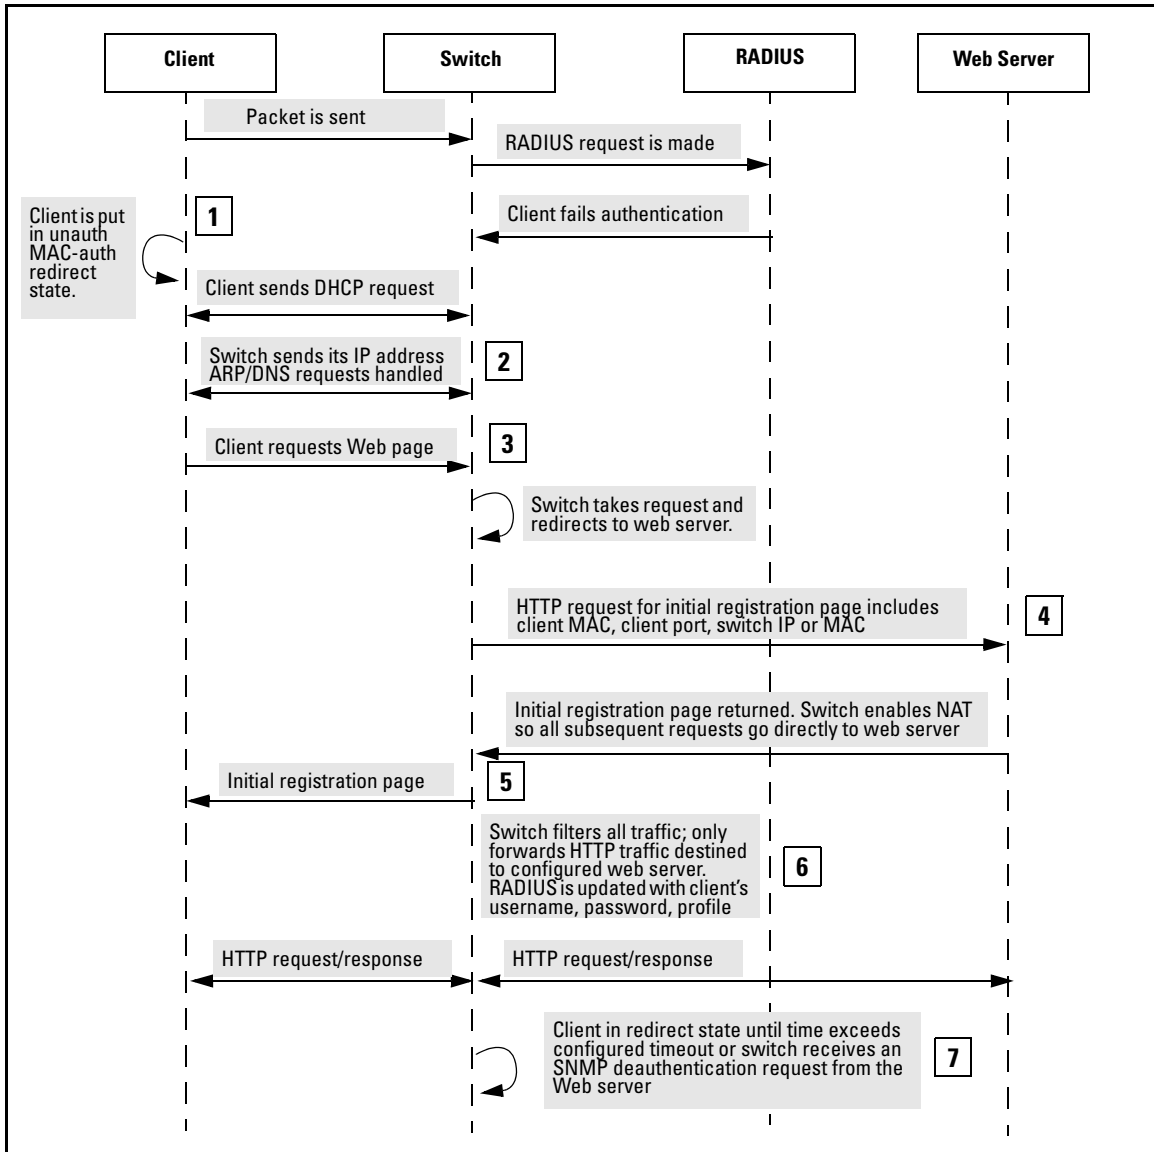
Diagram of Registration Process

1. When the redirect feature is enabled, a client that fails MAC authentication is moved into the unauthorized MAC authentication redirection state.
2. A client in the redirect state (having failed MAC authentication) with a web browser open sends a DHCP request. The switch responds with a DHCP lease for an address in the switch's configurable DHCP address range. Additionally, the switch's IP address becomes the client's default gateway. All ARP/DNS requests are handled by the switch and all requests are directed to the switch. The switch replies to these requests with its own address.

8. The switch moves the client out of the special Web/MAC auth redirect state and the client becomes unknown to the switch again. This sets the stage for a new MAC authentication cycle.

Figure 8. Example of Registration Process Using Redirection

When a client's MAC address is checked by the RADIUS server against the known list of MAC addresses, and the MAC address is not found, the client needs a way to quickly become registered through a web registration process. The HTTP Redirect feature provides a way for a client who has failed MAC authentication to become registered through a web/registration server. Only a web browser is required for this authentication process.
