Release Notes:

Version K.14.84 Software

for the HP Series 3500, 3500yl, 5400zl, 6200yl, 6600, and 8200zl Switches

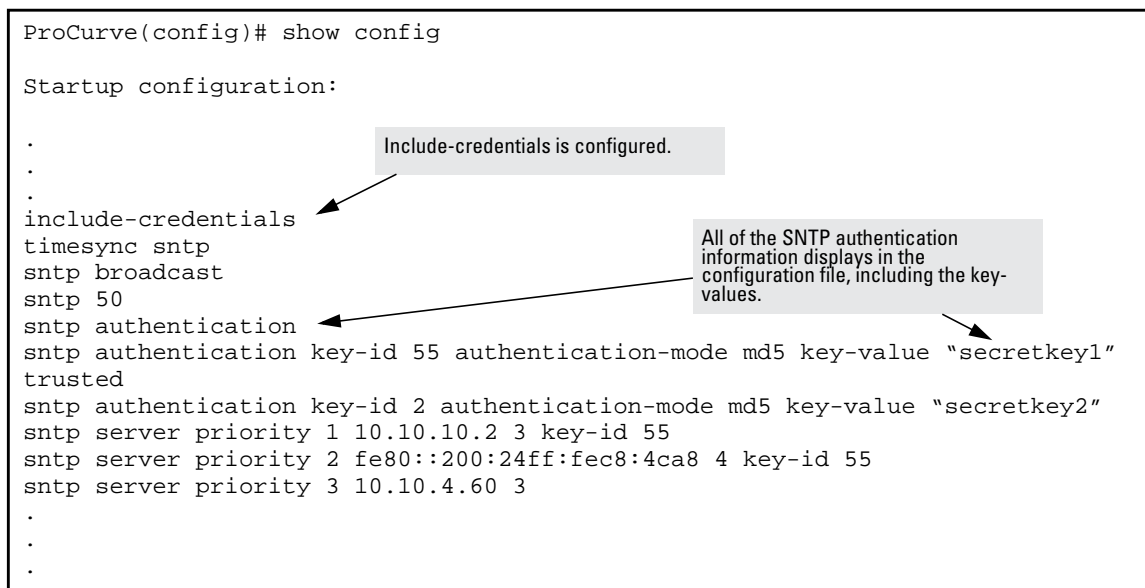
Figure 30. Example of Saved SNTP Authentication Information when include-credentials is Configured

Startup configuration:
.
.
.
include-credentials
timesync sntp
sntp broadcast
sntp 50
sntp authentication
sntp authentication key-id 55 authentication-mode md5 key-value "secretkey1"
trusted
sntp authentication key-id 2 authentication-mode md5 key-value "secretkey2"
sntp server priority 1 10.10.10.2 3 key-id 55
sntp server priority 2 fe80::200:24ff:fec8:4ca8 4 key-id 55
sntp server priority 3 10.10.4.60 3
.
.
.
```

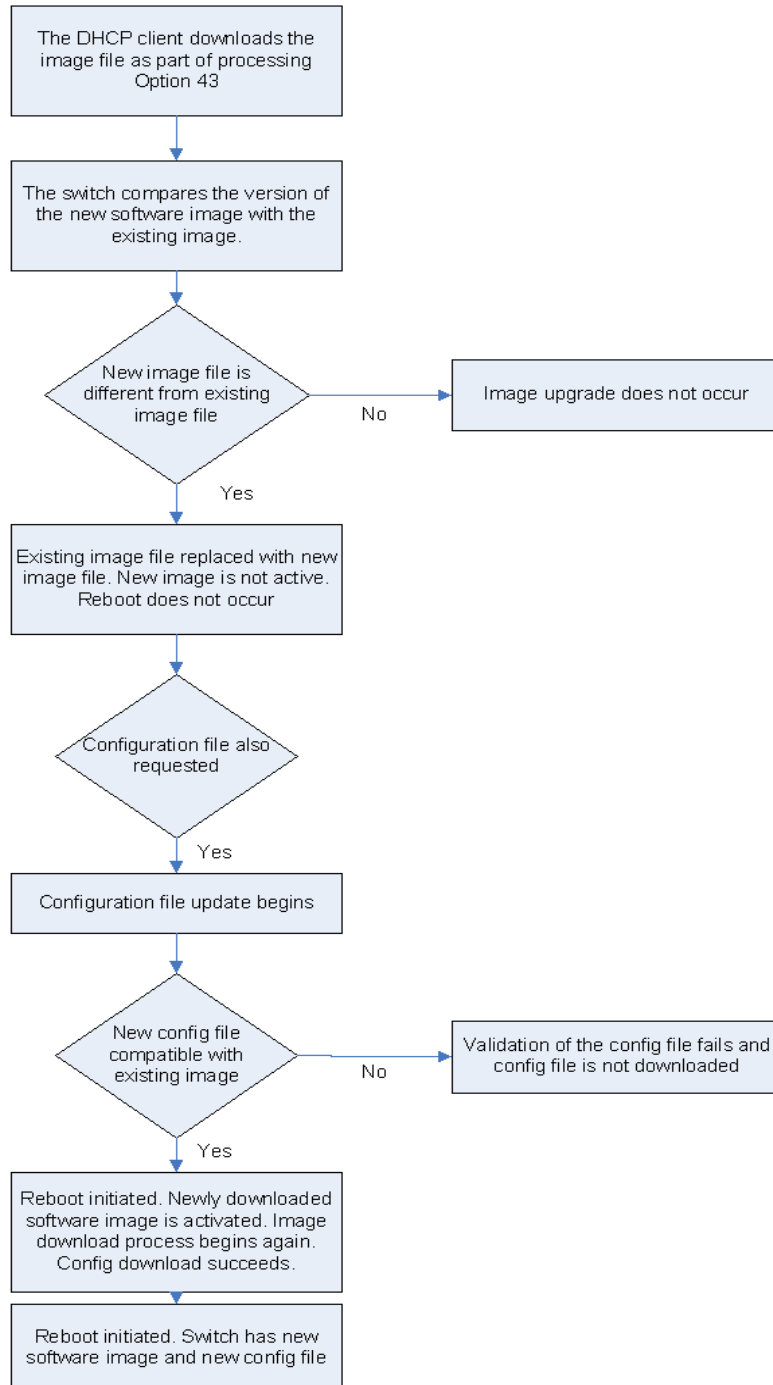
1. The DHCP client downloads the image file as part of processing DHCP option 43.
2. After downloading the file, the switch compares the version of the new software image file with the existing image file. If the new file is different from the existing file, the existing image file is replaced with the new image file. At this point the newly downloaded image is not the active image. A reboot does not immediately follow the image file replacement.

3. If the configuration file is also requested via DHCP options 66 and 67, the configuration file update begins. If the new configuration file is compatible with the existing image, the configuration download is successful and a reboot is initiated. The validation of the new configuration file may fail if the file contains an command that is ONLY supported by the newly downloaded image file, which is not yet active.

4. If the new configuration file is not compatible with the existing image, the configuration download fails and a reboot is initiated. The newly downloaded software image is activated.

7. The switch now has the new software image and the new configuration file.

The following diagram illustrates the steps.

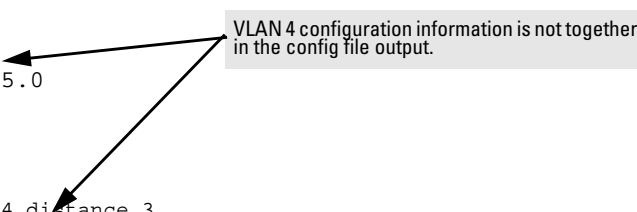
Figure 88. Example of Running Config Output Showing VLAN Information

hostname "ProCurve Switch 5412z1"
module 1 type J9309A
module 3 type J8702A
module 6 type J8702A
ip routing
vlan 1
  name "DEFAULT_VLAN"
  untagged A1-A4,C1-C24,F1-F24
  ip address dhcp-bootp
  exit
vlan 2
  name "test-vlan-2"
  ip helper-address 4.1.1.1
  ip helper-address 5.1.1.1
  ip address 1.1.1.1 255.255.255.0
  ipv6 address 2001::/64 anycast
  ipv6 enable
  exit
vlan 3
  name "VLAN3"
  ip helper-address 7.1.1.1
  ip forward-protocol udp 7.1.1.1 snmp
  ip forward-protocol udp 11.1.1.2 dns
  no ip address
  exit
vlan 4
  name "VLAN4"
  ip address 5.1.1.1 255.255.255.0
  ip bootp-gateway 5.1.1.1
  exit
logging 10.0.102.90
logging system-module ospf
ip route 5.1.1.0 255.255.255.0 vlan 4 distance 3
```

VLAN 4 configuration information is not together in the config file output.

Figure 88 is an example of the running config output showing VLAN information.

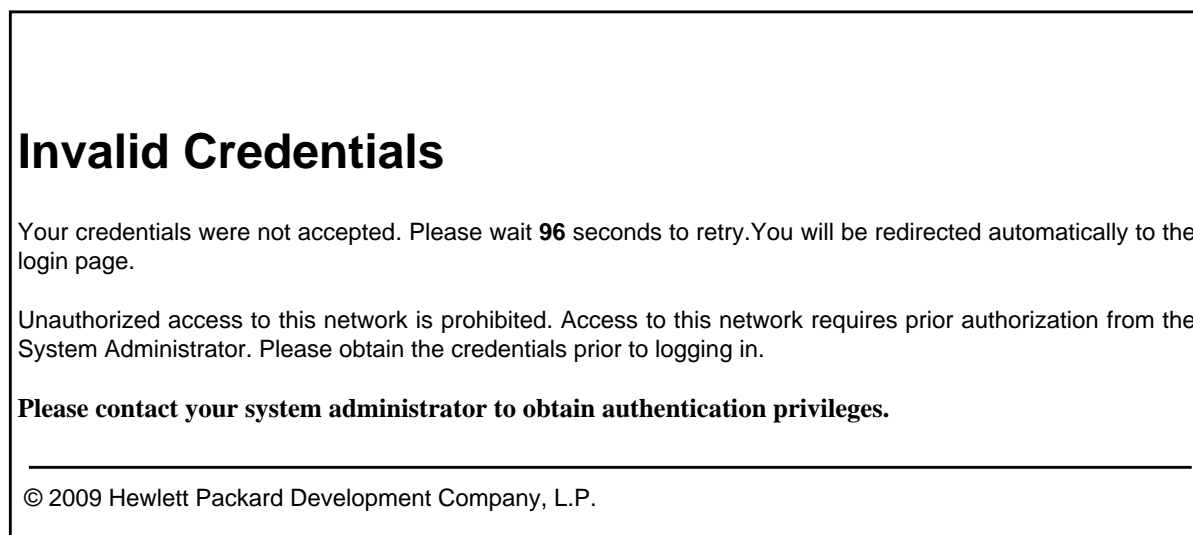
Figure 102. Example of Web Page with Configured Access Denied Message When unauth-vid is not Configured

Figure 102 shows an example of a web page displaying the access denied message when an **auth-vid** is not configured.
